Influence of electroplating stages on hydrogen pickup in SAE 1005 steel

María N. Delpupo*, Mariano N. Inés, Graciela A. Mansilla

Grupo Metalurgia Física, Departamento Metalurgia/DEYTEMA. Facultad Regional San Nicolás, Universidad Tecnológica Nacional, Colón 332, San Nicolás de los Arroyos, 2900, Argentina.

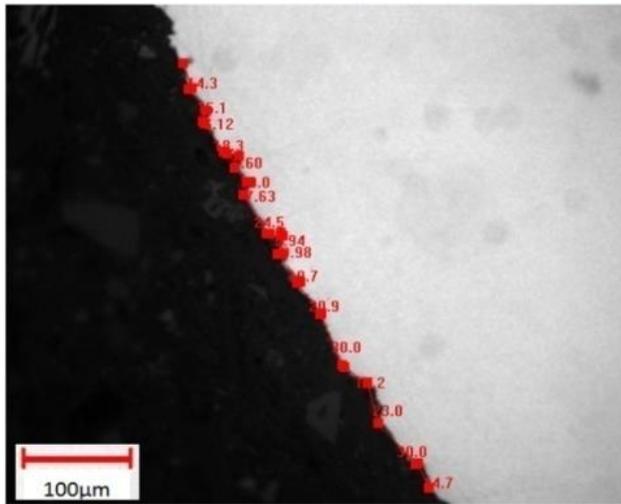
Roughness profile was determined by contour segments measurements, following the irregularities caused by pickling, using a LECO IA 32 image analyzer attached to an Olympus GX51 microscope, **Fig. 1**. A non-galvanized commercial wire sample was taken as reference. In this context, the perimeter increment is associated to a Roughness index. Under these conditions, samples 4D has shown 6% increase in roughness with respect to as received or pickled at room temperature [21-22].

Fig. 1. Sample profile measurements (500X).

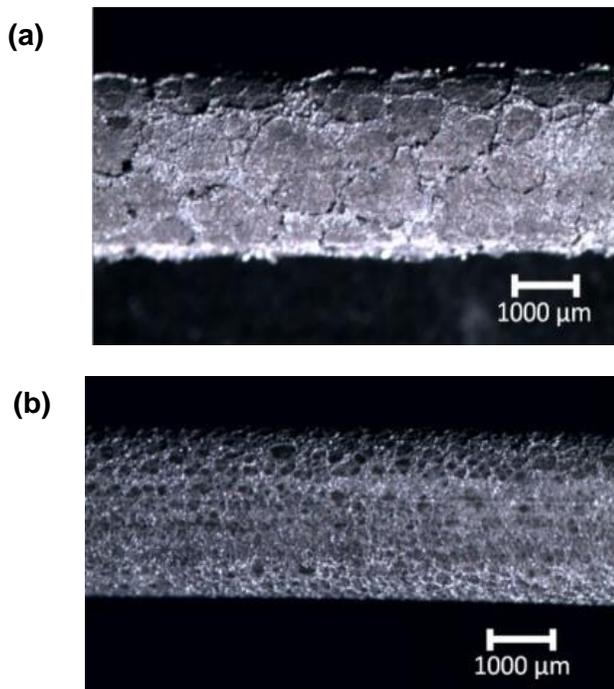
Coating thickness was measured for galvanized samples under conditions described in Table 2. Concerning with sample in Fig. 2(a), the large amount of Zn agglutinated they probably indicates that they were caused to H bubbles were adhered to the surface, forcing Zn depositing on the free spaces between them. On the other hand, sample 4G has similar thickness to that of the commercial one but discontinuous. Whereas for samples pickled at 40°C, coatings present greater adhesion to the wire and less quantity of Zn deposited, Fig. 2(b). Besides, the relationship between roughness and coating average thickness show that sample 4D has higher roughness and, although the coating thickness is lower, it turned out to be uniform. However, sample 1D, presents a smaller roughness, a greater coating thickness but not uniform (presence of agglutinated Zn). It is known that, the grip and the uniformity of the coating are function of the roughness achieved in the pickling stage, which contributes to a lower H diffusion. According to reference [11-12] the pickling is a potential source of H income. As described, the greater the roughness, the greater the grip of the coating on the base metal and lower is the probability of H income into the structure. Then, under experimental conditions, it is inferred that sample 1D (less rough) will present greater susceptibility to H damage since it offers a smaller surface for the H₂ recombination process, as studied by Pérez Escobar et al. [24]. The results obtained up to now; show that temperature and time during pickling have the highest impact on surface roughness which directly influences coating adhesion and its relation with possible H absorption. Summarizing, the best variables combination used during electrolytic pickling that allowed to obtain suitable roughness conditions and a good adherence [21-22] to the base metal were: temperature (40°C), voltage (1.5V) and pickling time (180s), i.e. sample 4D. In the same direction, during electroplating different currents, times and temperatures were used in order to determine the influence of each of them on the quality of the final coating in Table 2.

Fig. 2. (a) Electrogalvanized wires at room temperature, (b) at 40°C (1,2X).

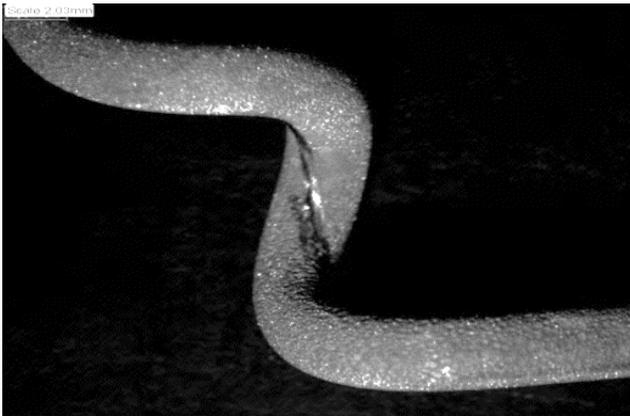
Fig. 3. Sample 5G winding test (0,67X)

The results obtained in SAE 1005 steel wires show that the bath temperature exerts influence on the coating grip to the base steel meanwhile electrodeposition current influences on its uniformity. Industrially a way of testing coating grip quality is by means of winding test, depicted in Fig. 3 for sample 5G. Scarce coating cracking in compression zones were observed but coating stay intact at tension ones putting the coating suitable for subsequent uses. Evidence collected up to now allows determining that critical stages of hydrogen income are pickling and electroplating. Also that the main electrochemical parameters are current and electrolytic solution temperature, playing an important role at each stage and must be carefully observed.

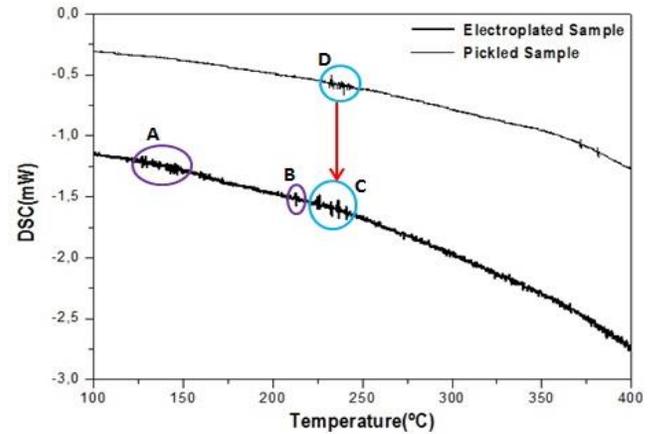
Differential scanning calorimetry tests were performed on sample 5G with the aim of analyzing hydrogen absorption during pickling and electroplating processes, Fig. 4. Tests were conducted in a Shimadzu model DSC-60 differential calorimeter, from room temperature to 400°C at a heating rate of 2°C/min. This technique allows classifying hydrogen traps into strong and weak in connection with absorption /desorption energy peaks obtained. To clarify understanding of activation energies analysis, the temperature range was divided into: zone 1 from 100°C to 200°C; zone 2 from 200°C to 300°C; and zone 3 from 300° to 400°C and only the higher energy desorption peaks per zone were considered.

Fig. 4. Released energies vs. temperature obtained in DSC tests.

Note that from the absorbed/desorbed energies curves, the one corresponding to the pickled sample (upper curve), is developed for greater energy values of than that corresponding to the galvanized sample (lower curve). It can also clearly seen in galvanized sample, there are peaks of absorption/desorption energy (peaks B and C) in coincidence with those in the pickling curve (peak D). It can also clearly seen in galvanized sample, there are peaks of absorption/desorption energy (peaks B and C) in coincidence with those in the pickling curve (peak D), indicating that galvanizing can avoid H exit introduced in pickling operations. As it is described by author [25], who using TDA for dual-phase steels indicate that zinc hinders the escape of H from the steel and that the desorption peaks are close to 250°C. In present case, hydrogenation occurs between 200°C and 250°C due to H trapped in the pickling stage. In this temperature range, greater amount of higher intensity peaks for the galvanized sample are manifested, from which it is inferred that H entered during pickling was reinforced by H trapped in electroplating stage, i.e., that the hydrogen is occluded by the coating [25-26]. On the other hand, the pickling stage produce H income in the range already mentioned as zone 2 between 200°C to 300°C. The knowledge of the specific sites where the H was trapped was obtained through the application of a specific metallographic technique [20]. Scanning electron micrographs reveals Ag (white) particles precipitated silicoaluminates, hint of H presence associated with them. Besides, less rough sample also presented silver particles at grain boundaries. This result, verify the close relationship between roughness and the H income during pickling. In this case, it was evidenced a significant amount of silver particles, mainly related to the inclusions and grain boundaries and consistent with several studies [12,21,27] where the pickling variables are related to winding tests which represent a measure of the coating's adhesion.

It is well known that H trapped may produce fails in steels, thus a method of H removal could be valuable. For example, some studies [28] have reported a decrease in H concentration for high-strength electrogalvanized steels, as a consequence of a 4h at 200°C treatment. According to calorimetric results, Fig. 4, it was decided to carry out an annealing heat treatment for 8 hours at 250 °C and cooling in the furnace in order to removed H absorbed during galvanizing procedure.

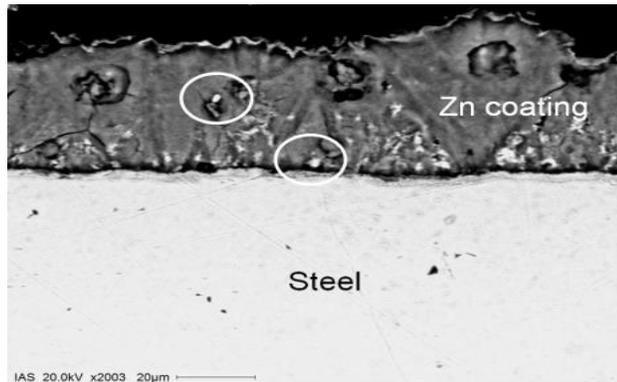
In contrast, scarce white particles were detected on less rough samples as expected. As a further matter, on zinc-coated sample shown in Fig. 5, silver particles, some them encircled, were detected inside the metal coating also in the wire. This suggest that the coating itself act as a barrier for H desorption that remained trapped at the interface.

Fig. 5. Scanning electron microscopy where white Ag particles in the Zn coating indicate H occlusion sites.

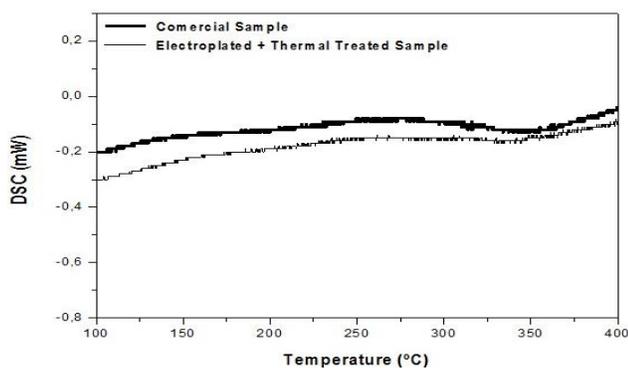
Besides, to check the effectiveness of thermal treatment, calorimetric tests were developed and outcome compared with corresponding sample of commercial galvanized wire. As expected, desorption of H trapped during galvanizing in laboratory was achieved. Always, commercial galvanized wire was kept as counter-sample and depicted simultaneously in **Fig. 6**. As shown, previously detected energy peaks due to electroplating disappeared, and the sample behaves like commercial ones. Similar result was pointed out by S. Brahimi [29], who attributed that hydrogen removed by suitable heat treatment would be which was free as interstitial in the steel network.

Fig. 6. Released energies vs. temperature after thermal treatments.
